Case Study 6

History

Design of Paromed Devices

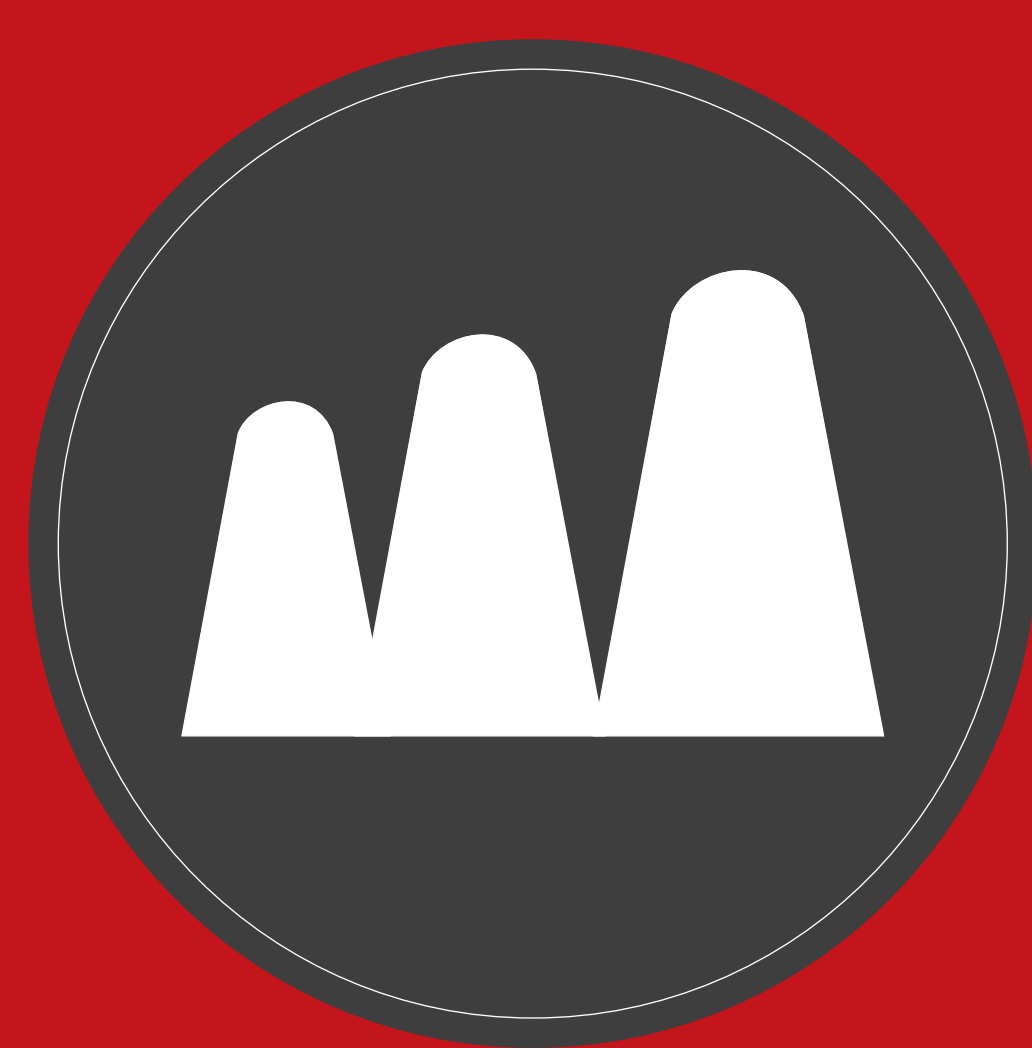
PRESSURE

- › Pathological forces found during normal gait pattern in regular footwear depicted in Parotec in shoe pressure measurement

- › Comparison of Parotec in-shoe pressure measurement, measurements taken without the orthotic and then over the top of the devices.
- › Lesions show immediate signs of healing within 3 weeks.

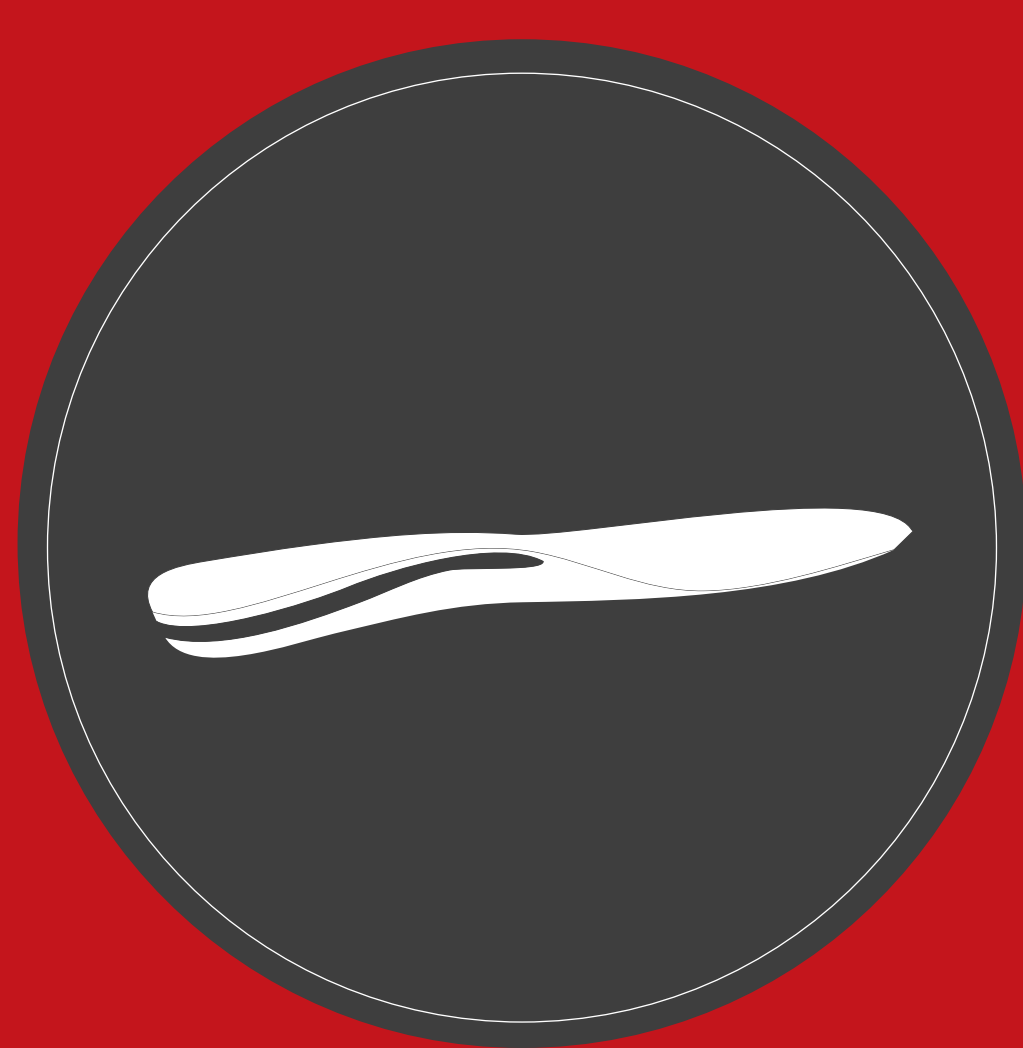
SCAN

- › Stationary 3-D weight bearing scan obtained
- › Ability to wipe down scanning surface post scan

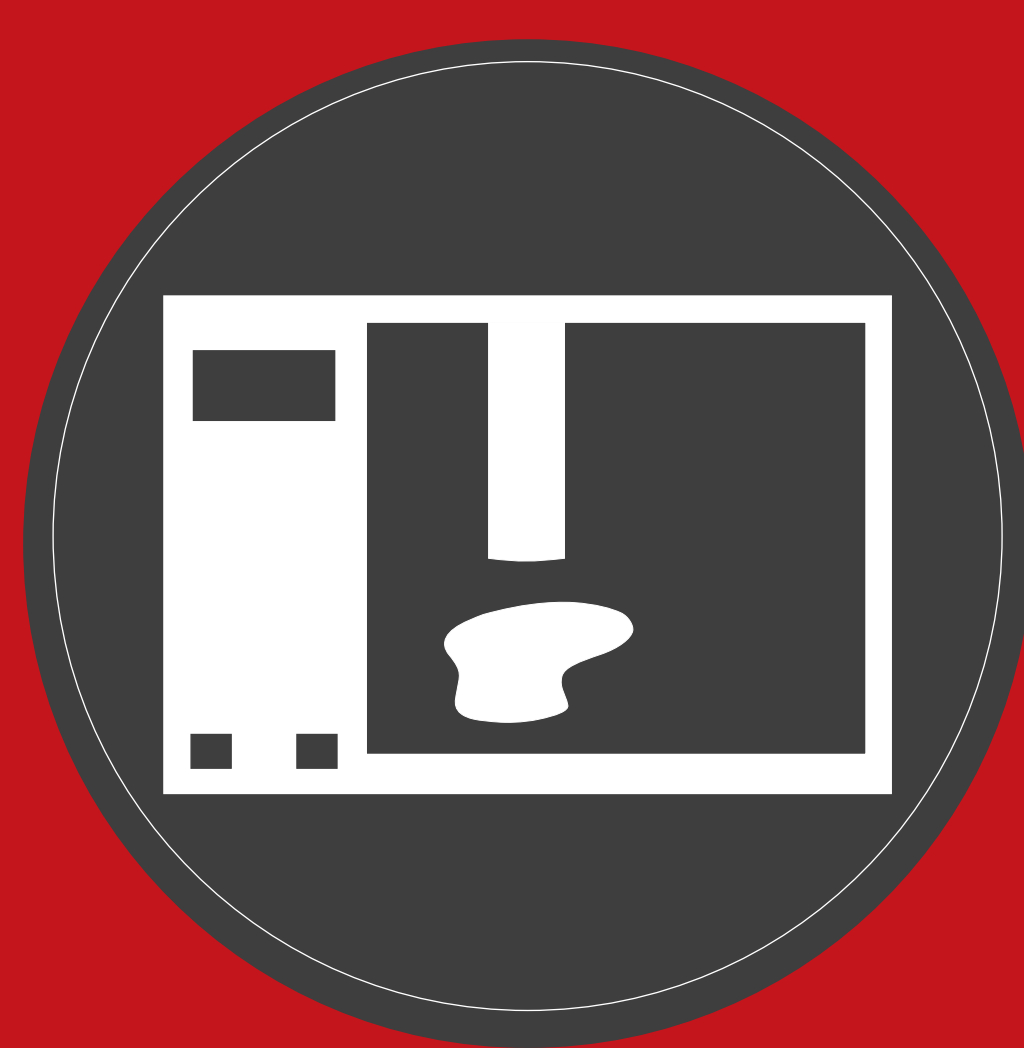
MODEL

- › Diabetic last chosen to fit all wide diabetic footwear.
- › Use of differential milling techniques to adequately offload ulcer sites
- › Density choices for pathology

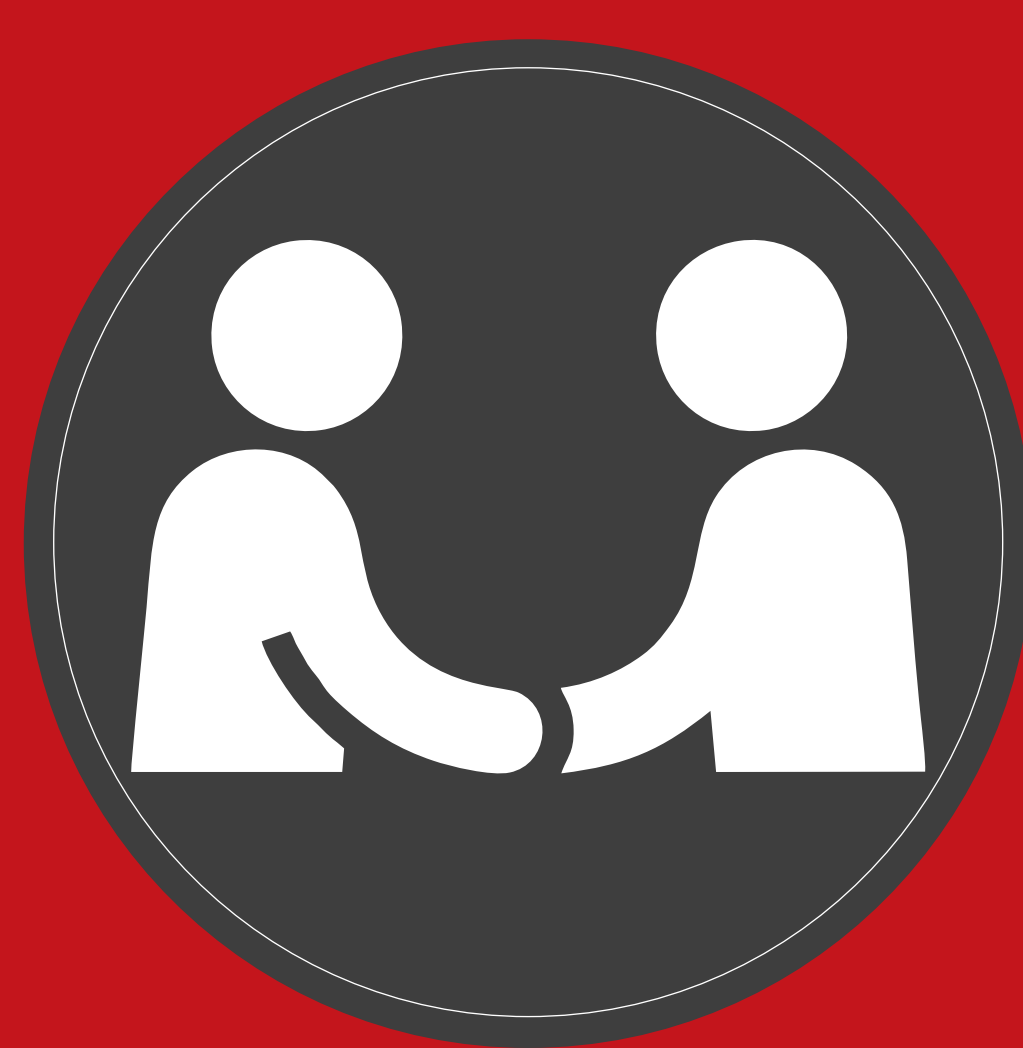
MILL

- › Milling of top and bottom sides
- › Automated poron filled apertures to offload specific sites as per design
- › No seams or ridges on apertures due to automation
